The Role of Non-Destructive Evaluation in the Engineering and Preservation of Concrete Structures

Thomas Schumacher, PhD, PE (DE)

CONCRETO
ACADEMY

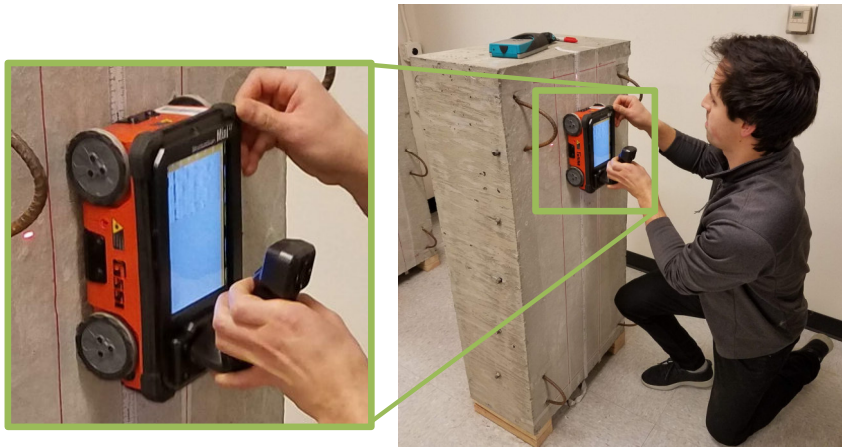
GPR scanning of RC specimen during graduate course.

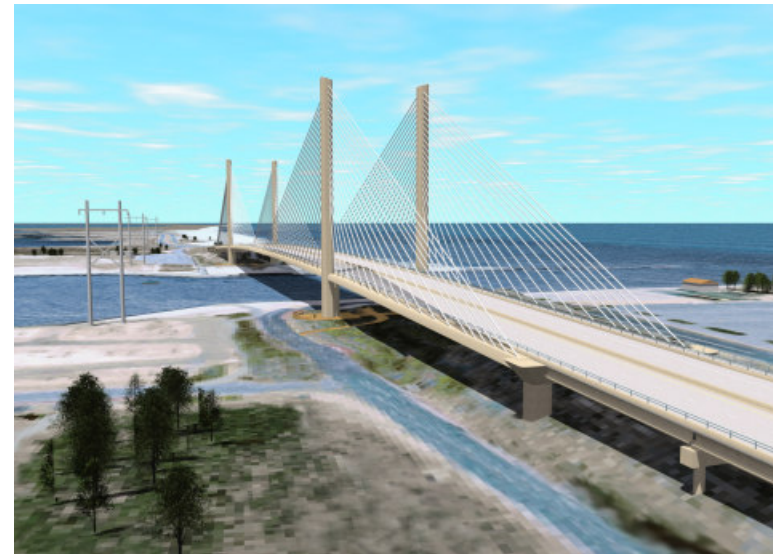
Long-term SHM of Indian River Inlet Bridge. Source: Skanska USA.

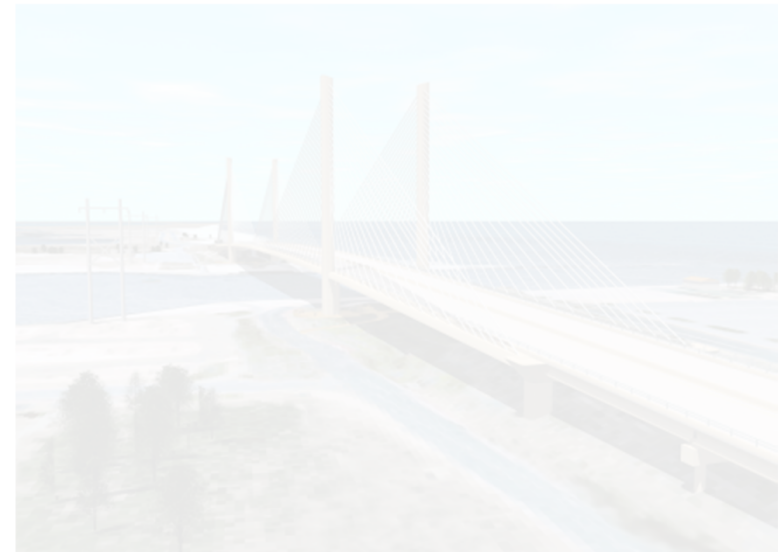
Long-term SHM of Indian River Inlet Bridge. Source: Skanska USA.

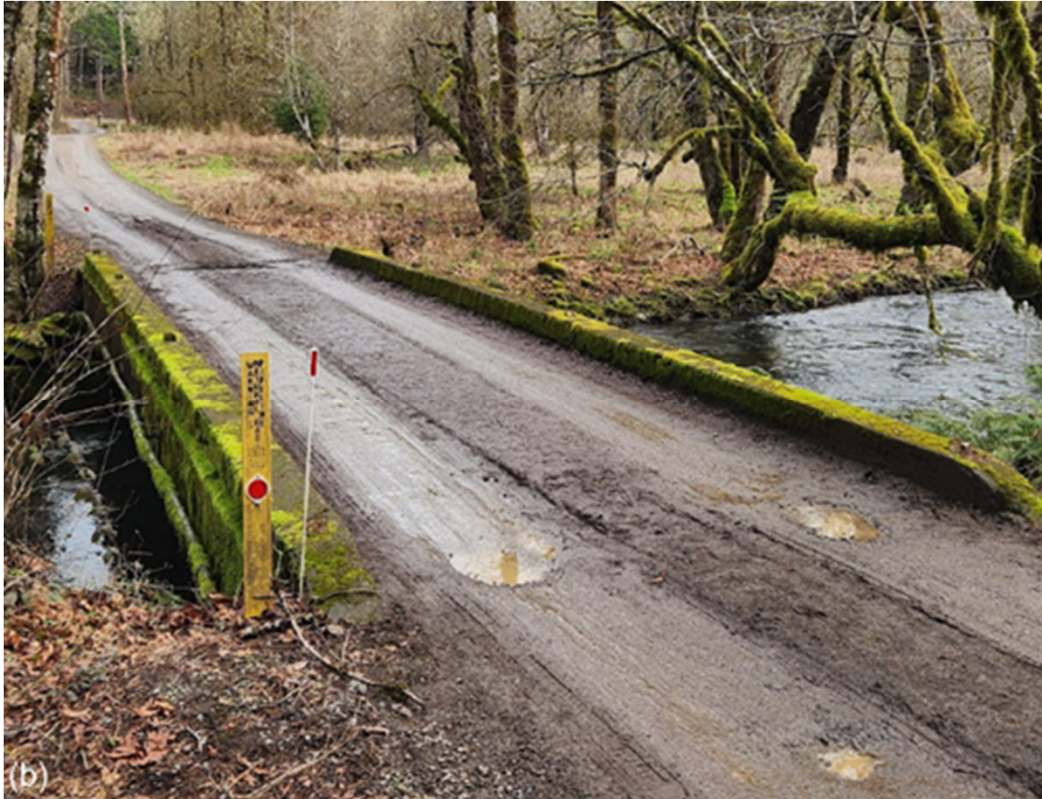
Case study 1: Background

Task: Bridge load rating

Problem: No as-built plans exist!

- Simply-supported, span ~ 14.6 m
- Three side-by-side prestressed concrete voided (?) slabs ($b \times h \times L = 1.22$ m \times 0.53 m \times 15.2 m)
- Transverse post-tensioning
- How many strands? Concrete cover?
- How many voids? Size? Location?

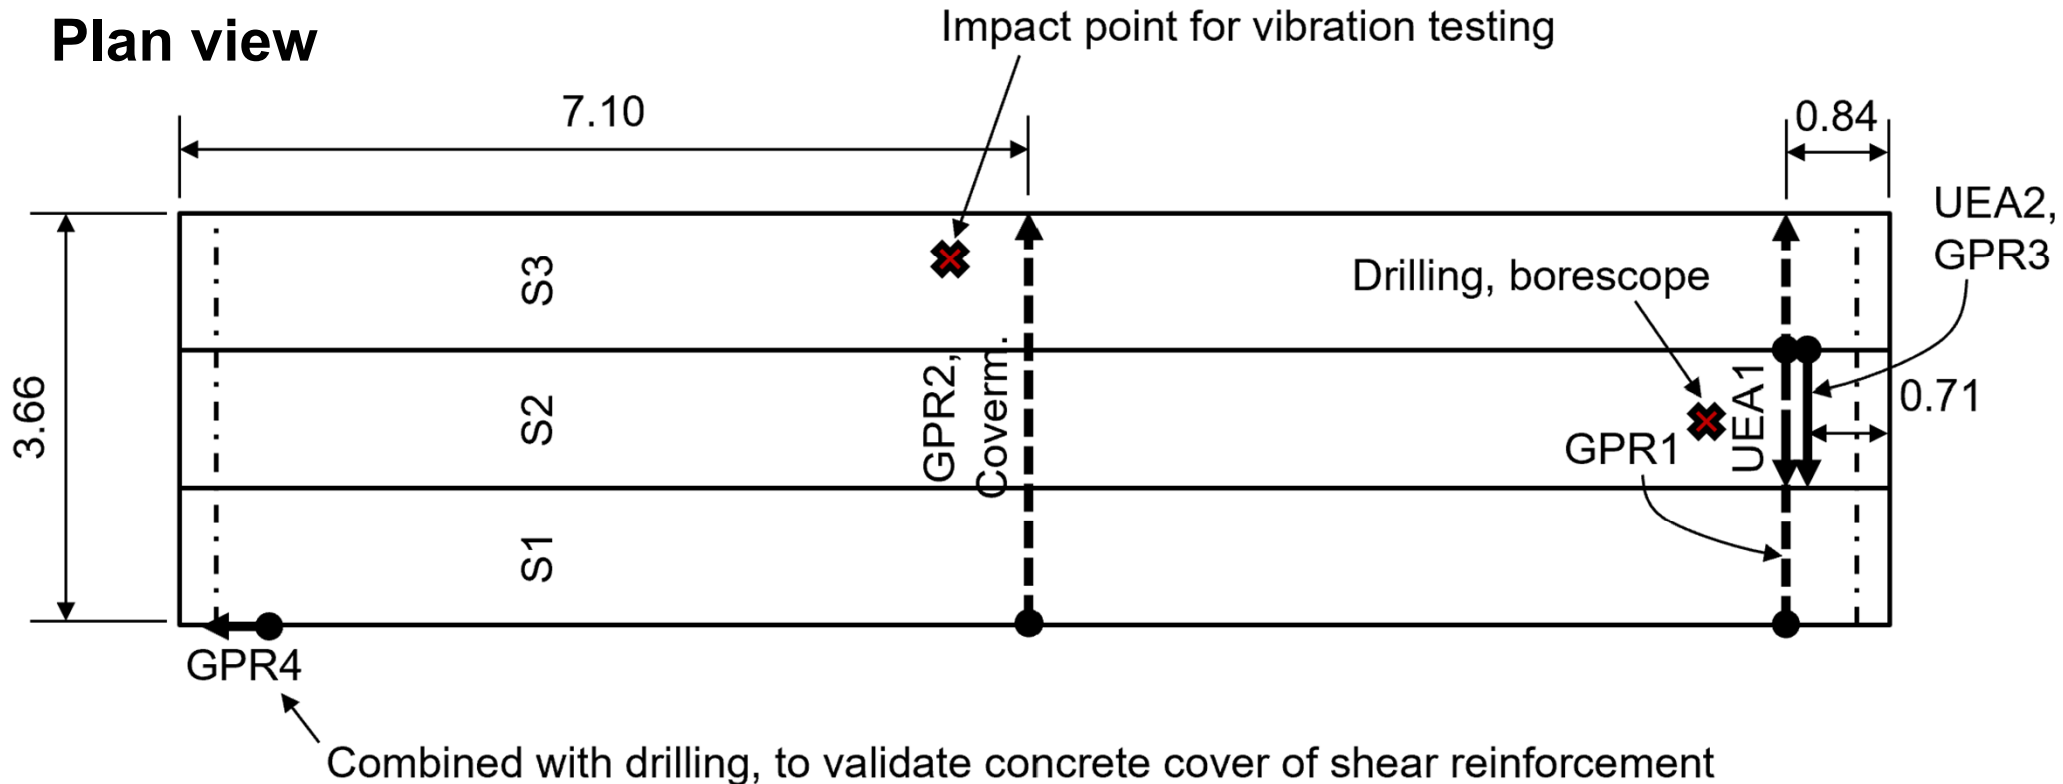
Plan view

Case study 1: Overview of NDT measurements

- Vibration testing \Rightarrow Structural parameters (span length, mass, stiffness)
- Covermeter \Rightarrow Concrete cover depth of prestressing strands
- Rebound hammer \Rightarrow Quality of concrete, surface hardness
- Drilling holes \Rightarrow Depth of shear rebars, location and content of void

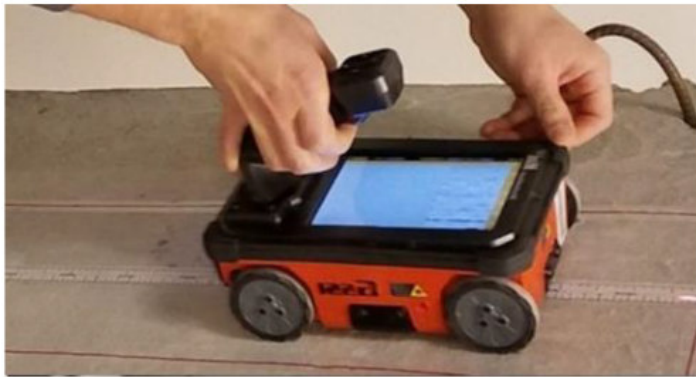
Ground penetrating radar (GPR)

Instrument: GSSI StructureScan Mini XT

Wave type:	Electromagnetic
Central pulse frequency:	2.7 GHz
Sampling frequency:	32 to 270 MHz
Spatial resolution:	2.5 mm
Number of transducers/rows:	2/1
Transducer spacing:	60 mm

⇒ Electromagnetic waves ideal for detecting **metallic objects**.

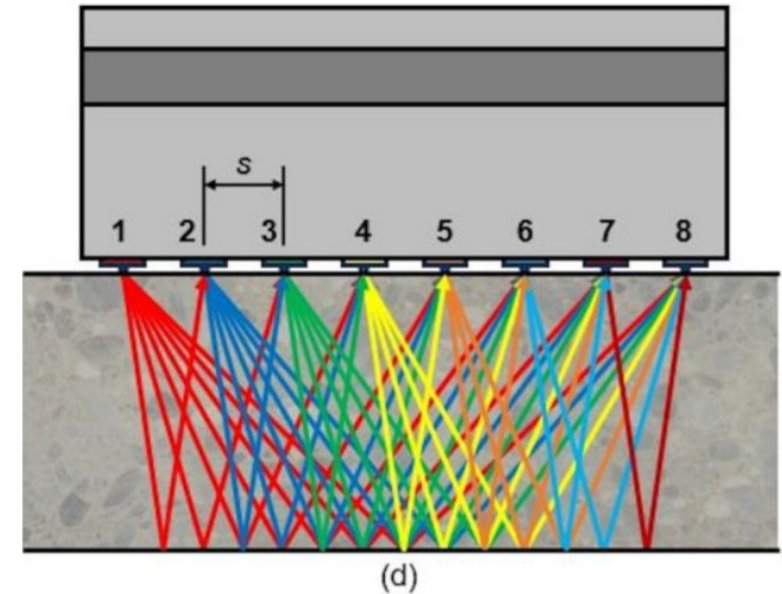
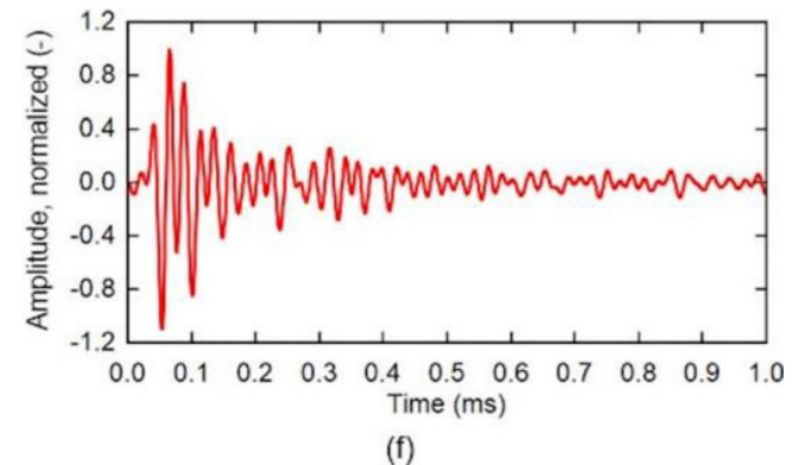
Ultrasonic testing (UST) using array

Instrument: Proceq Pundit 250 Array

Wave type:	Elastic stress
Central pulse frequency:	40 kHz
Sampling frequency:	1 MHz
Spatial resolution ^(*) :	10 mm
Number of transducers/rows:	8/3
Transducer spacing:	30 mm

⇒ Stress waves ideal for detecting **air voids and boundaries**.

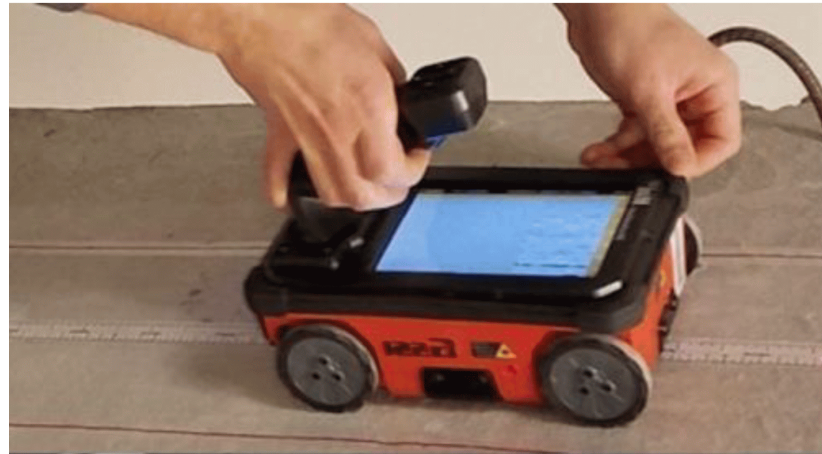
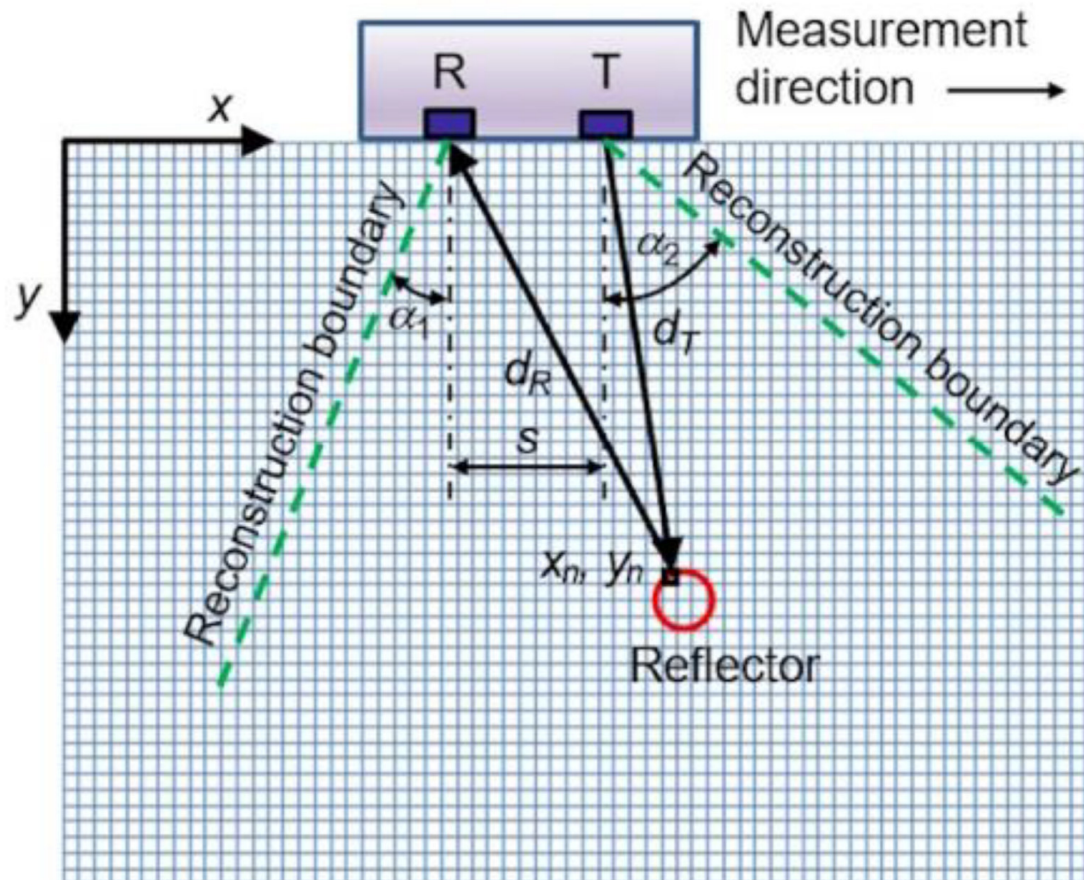
Synthetic aperture focusing technique (SAFT)

- Technique that generates a focused image of reflectors
- Unknown variables: **Wave speed** and **time off-set**
- Lots of processing options \Rightarrow **There is no “one way” to create an image!**

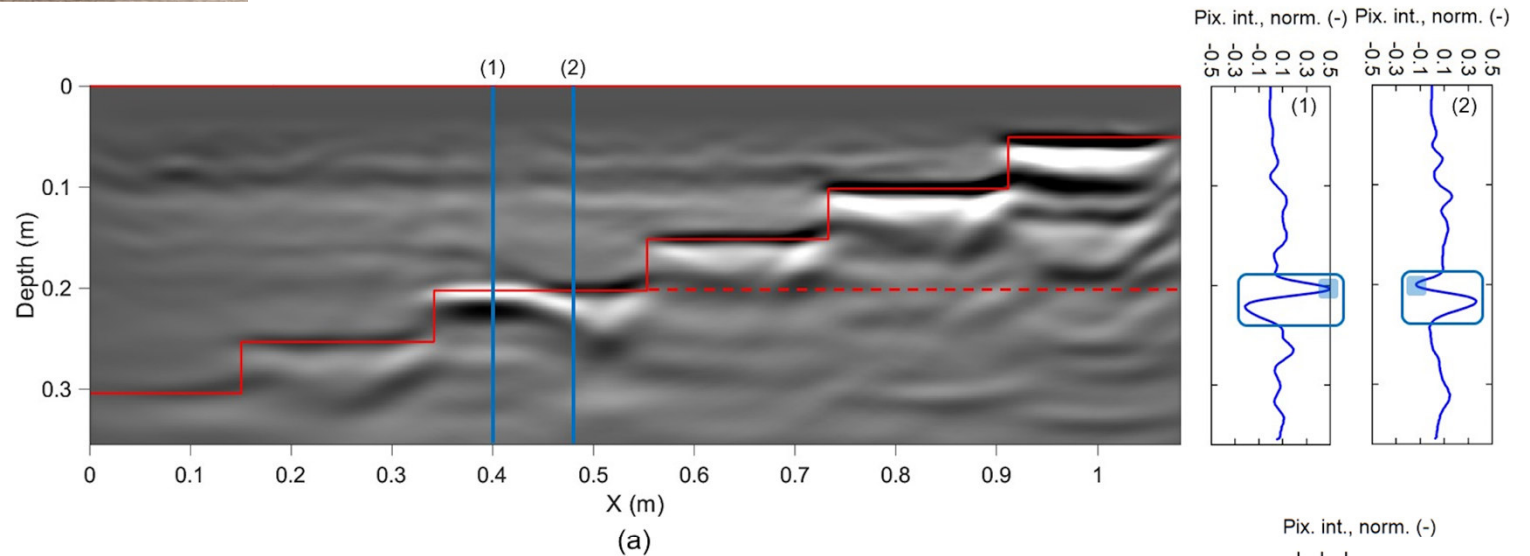
GPR

Calibration

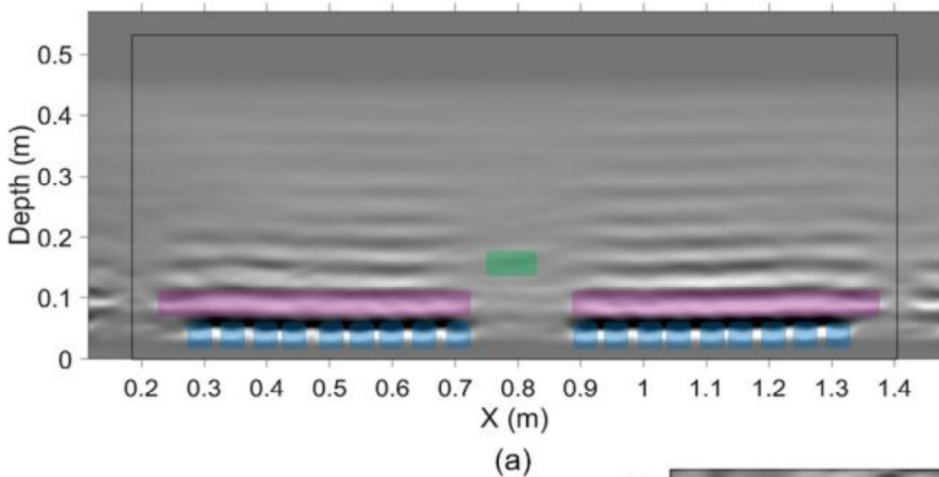
GPR image

Measurements taken from bottom

Calibrated EM
wave speed:
 $c = 3.48 \text{ in/ns}$
($88.5 \text{ m}/\mu\text{s}$)

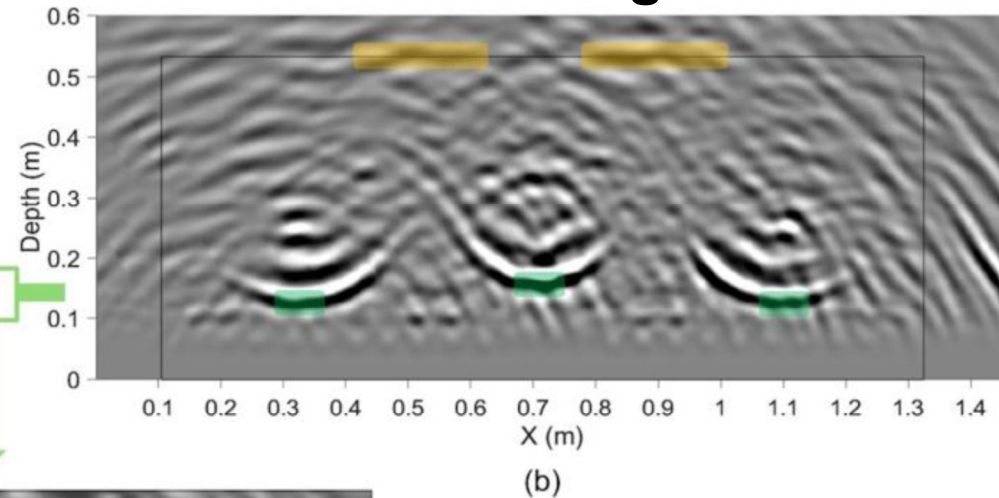
UEA image

Calibrated shear
wave speed:
 $c_s = 103 \text{ in/ms}$
(2.62 m/ms)

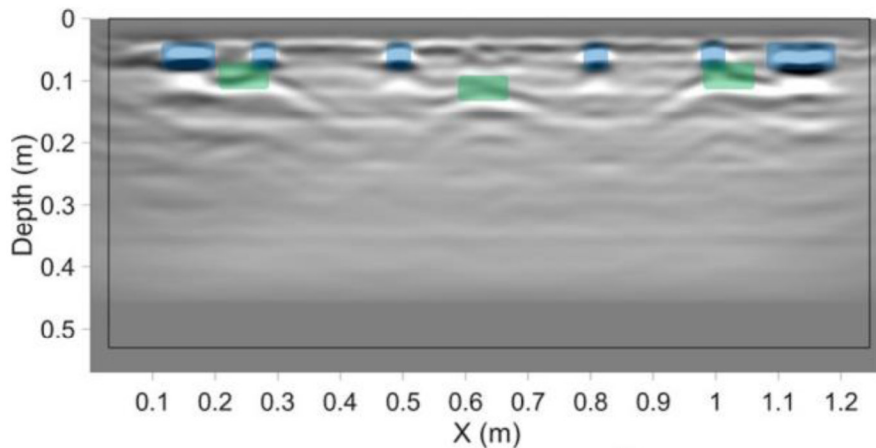
GPR image

Measurements taken from top

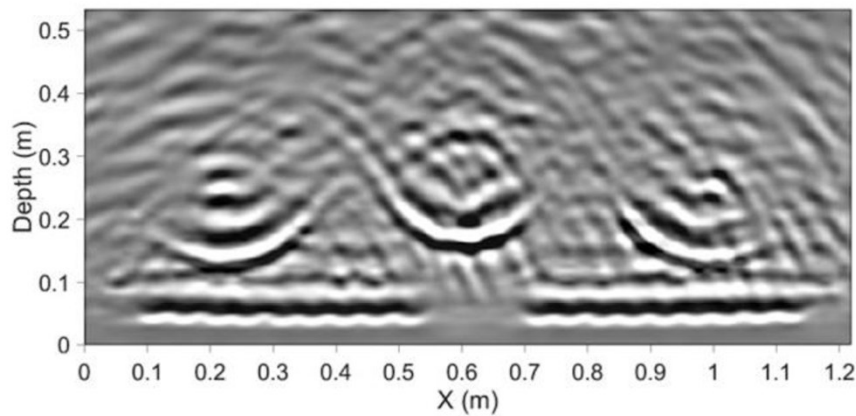
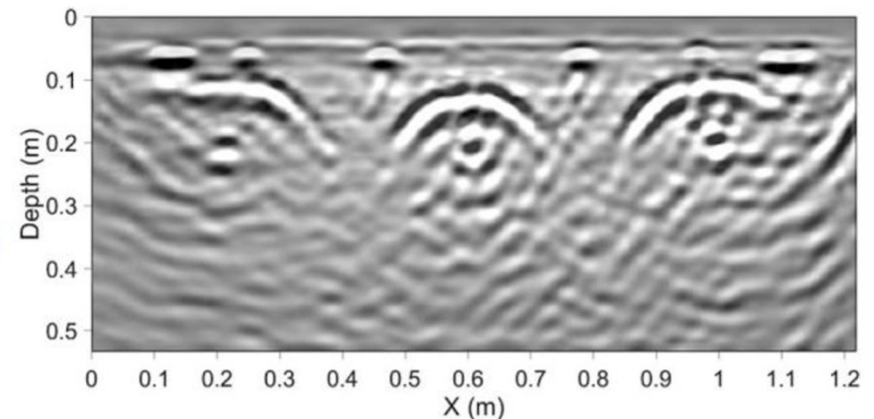
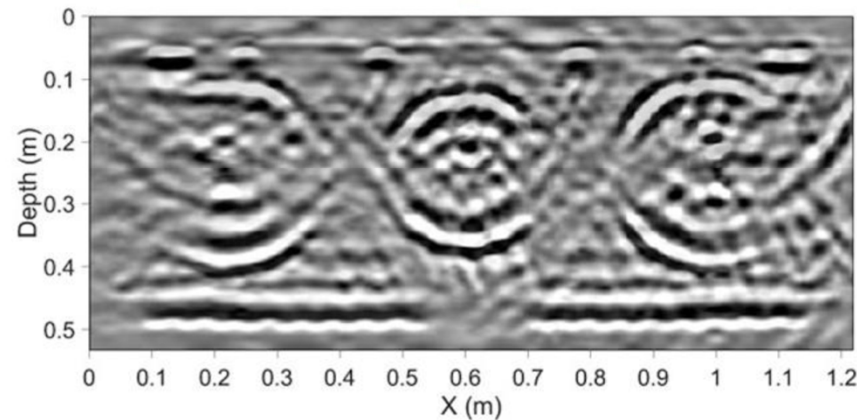
Final fused image

Fusion of fused images

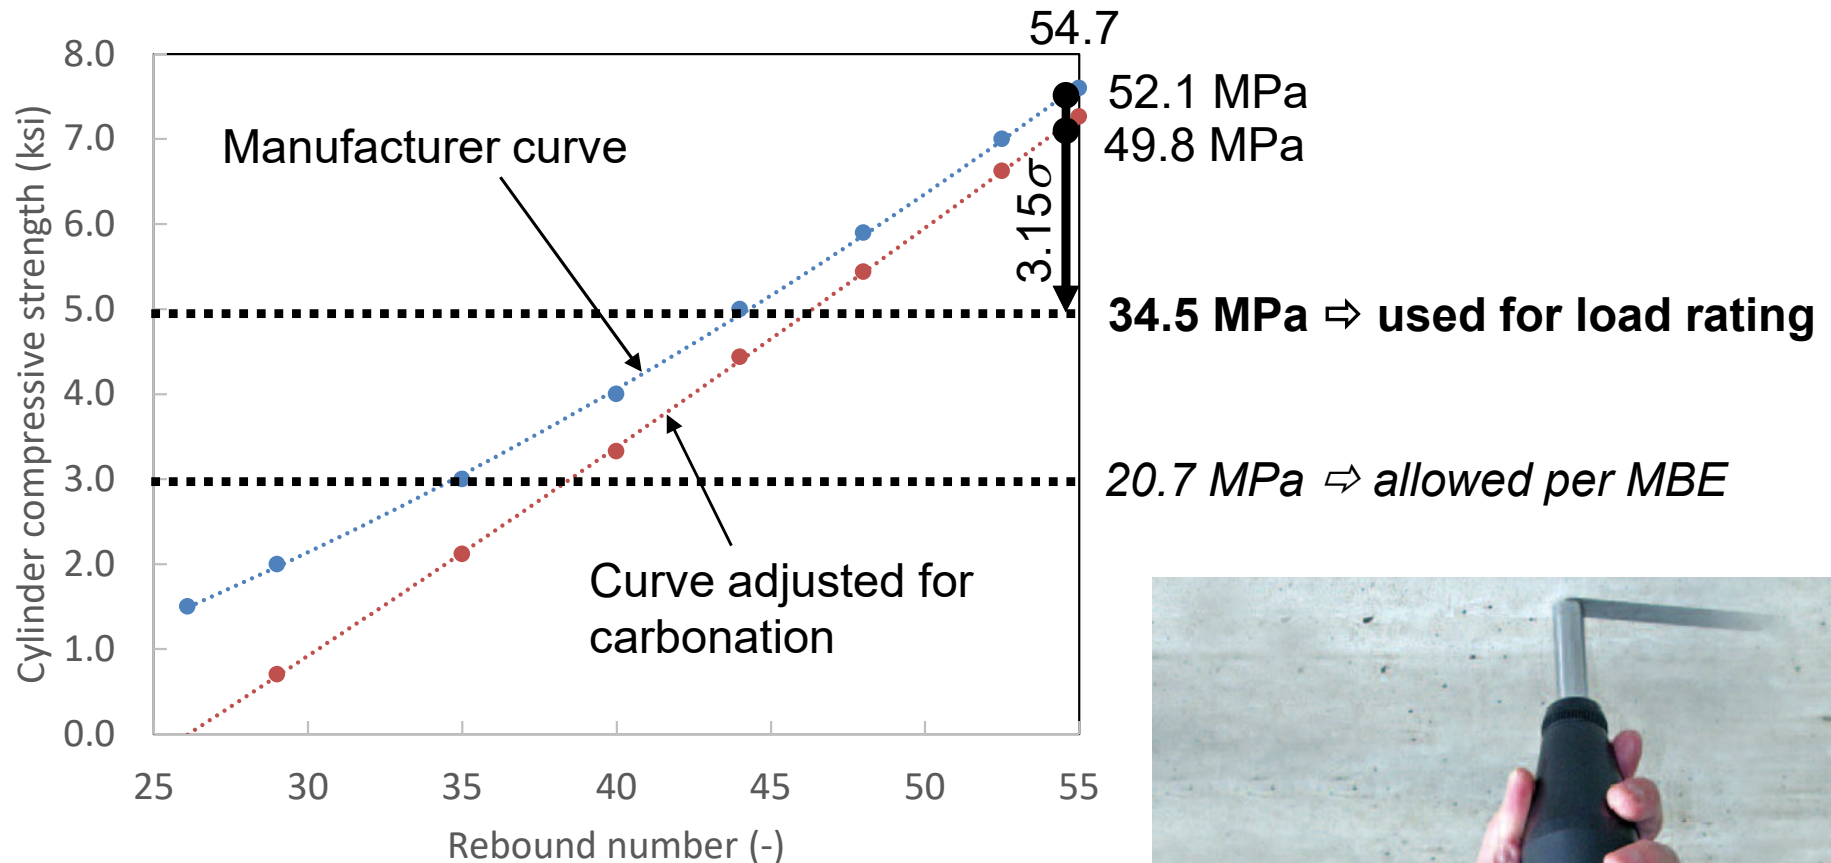
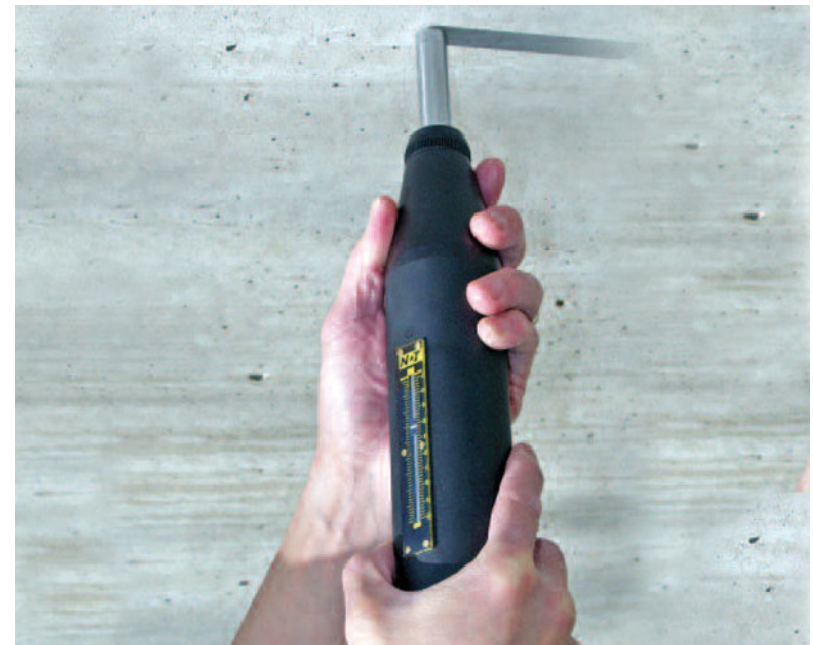
- Rebound number (James Instruments)

\Rightarrow 20 measurements at random locations

Remark: Testing was not performed in acc. with ASTM C805-18 but only to get a qualitative sense of surface hardness and concrete quality.

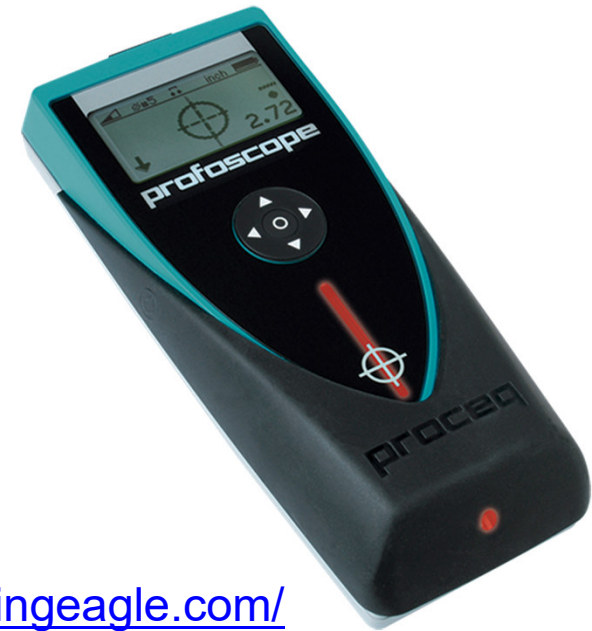
- Rebar detector (Proceq Profoscope)
 - Mean concrete cover across all 18 strands = 36 mm, C.V. = 3.5%

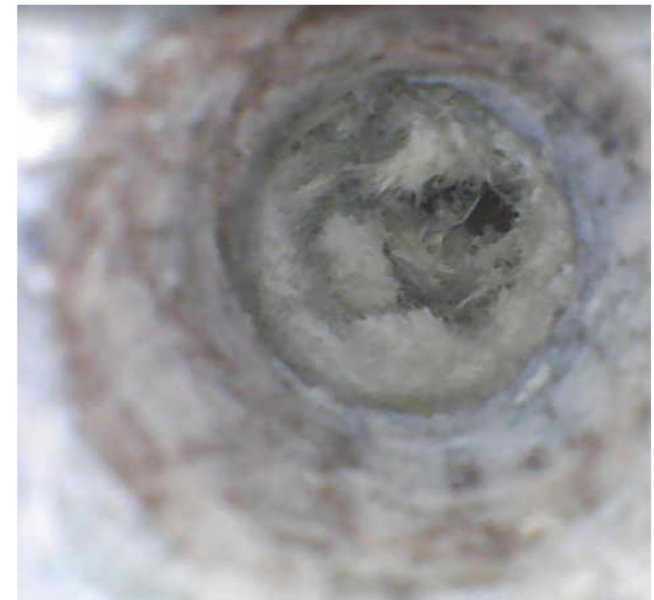
Photo from phone-based borescope

- Drilling hole into middle void from slab soffit
 - Void was present and dry
 - Formwork material fibrous board
 - Distance from slab soffit to bottom of void = 0.157 m

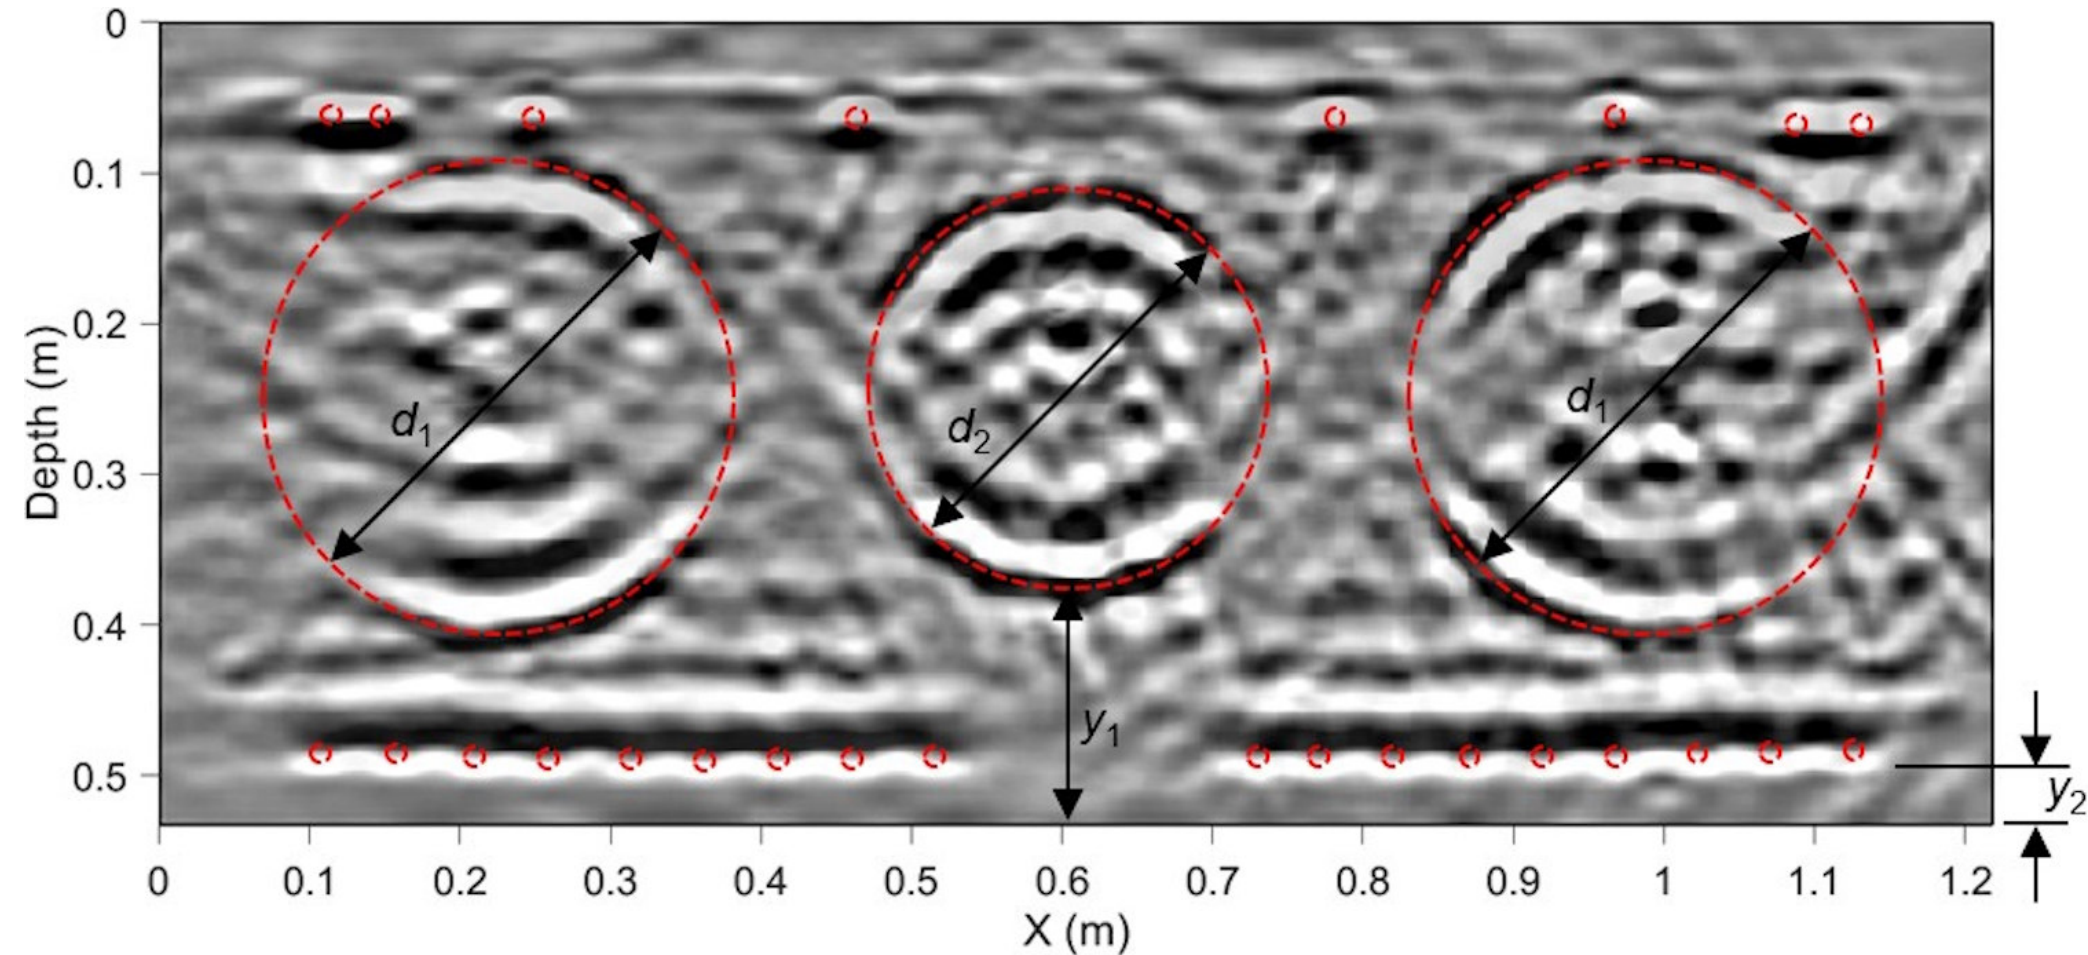
Extracted dimensions:

- $d_1 = 0.31 \text{ m}$
- $d_2 = 0.26 \text{ m}$
- $y_1 = 0.155 \text{ m}$ (confirmed by drilling)
- $y_2 = 38 \text{ mm}$ (confirmed by rebar detector)

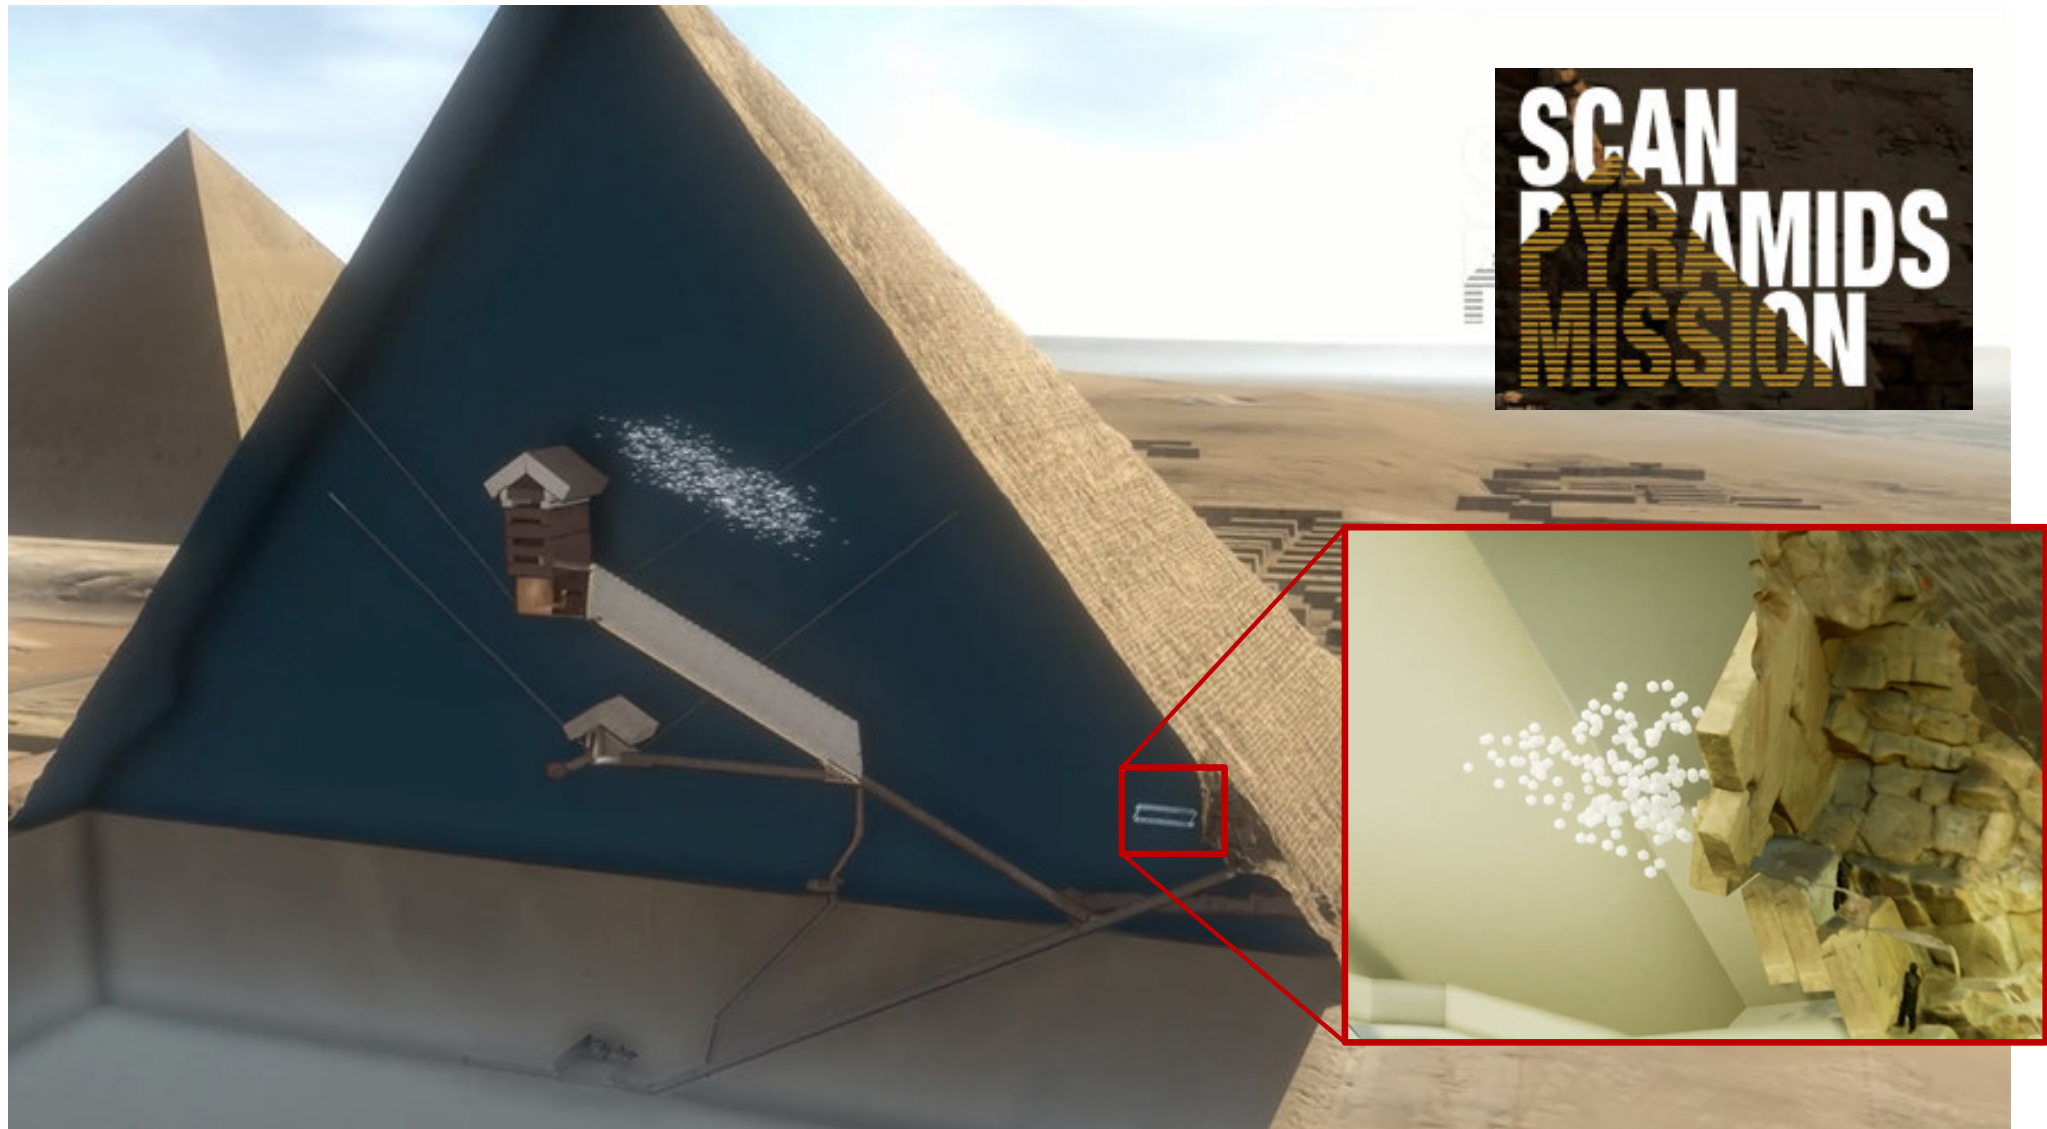
Case study 2: Results from muon tomography predict two previously hidden voids

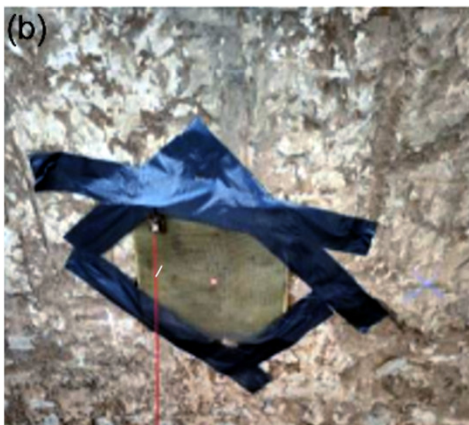
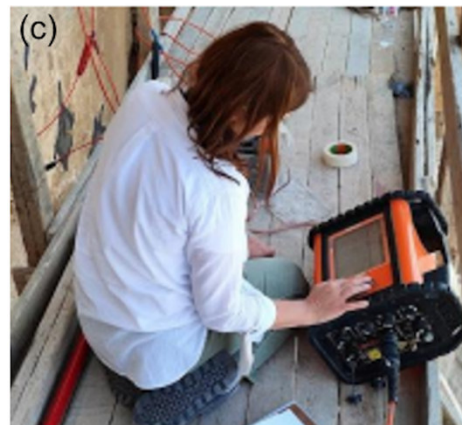
UST measurements

ERT measurements

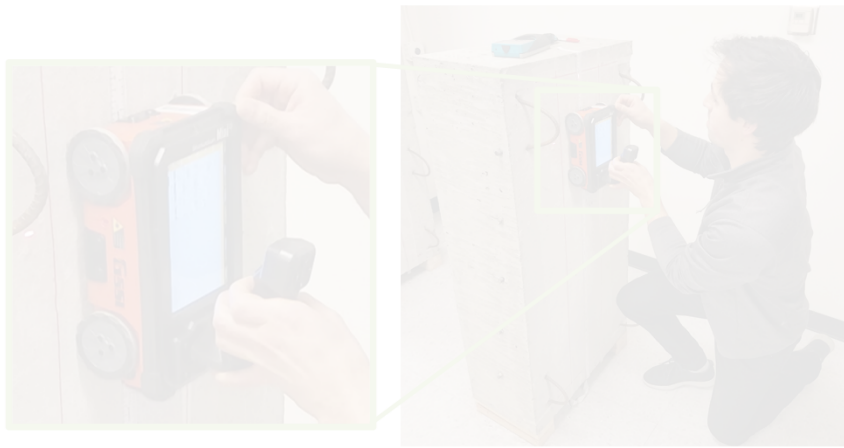
GPR scanning of RC specimen during graduate course.

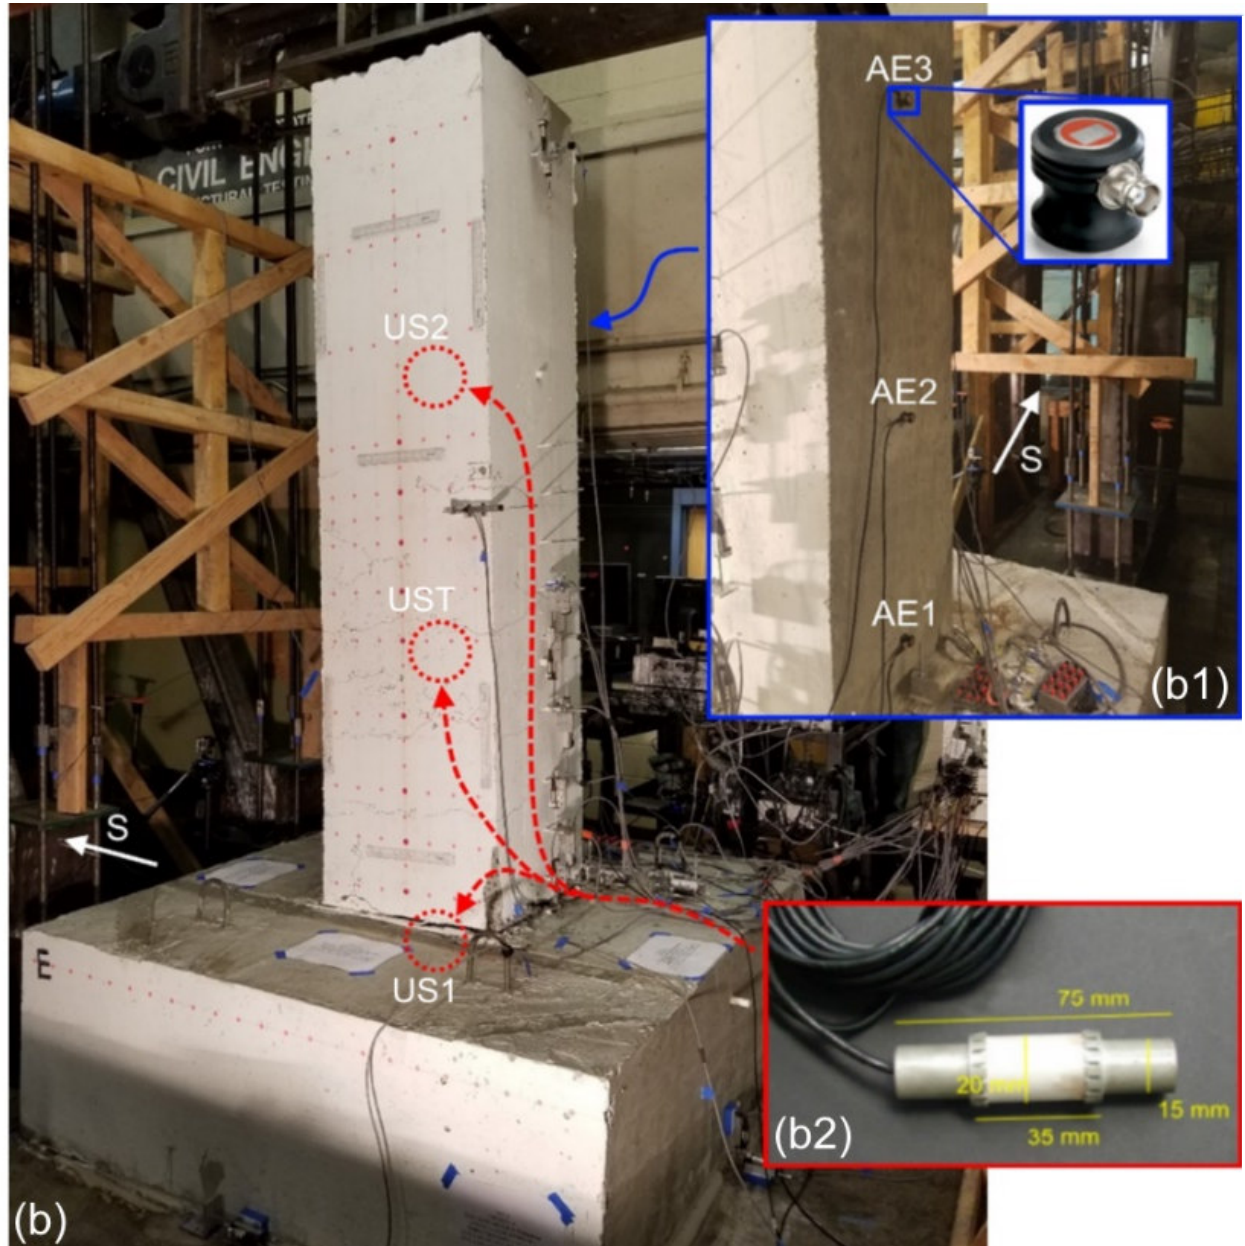
- Determine behavior of RC bridge piers with pre-1990s detailing under Cascadia mega-thrust earthquake
- Monitoring using embedded ultrasonic transducers to track degradation during loading

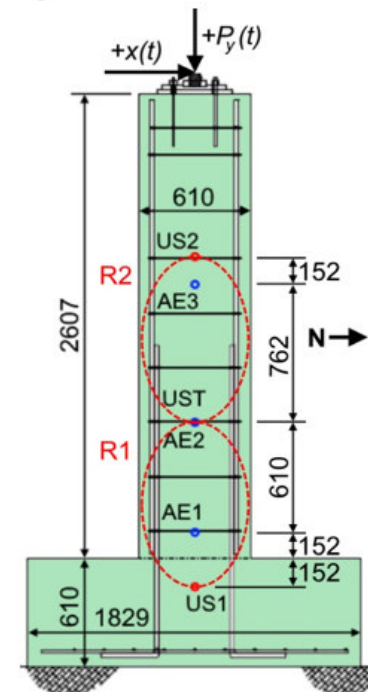
Combined passive and active ultrasonic monitoring can tell when and where cracking starts

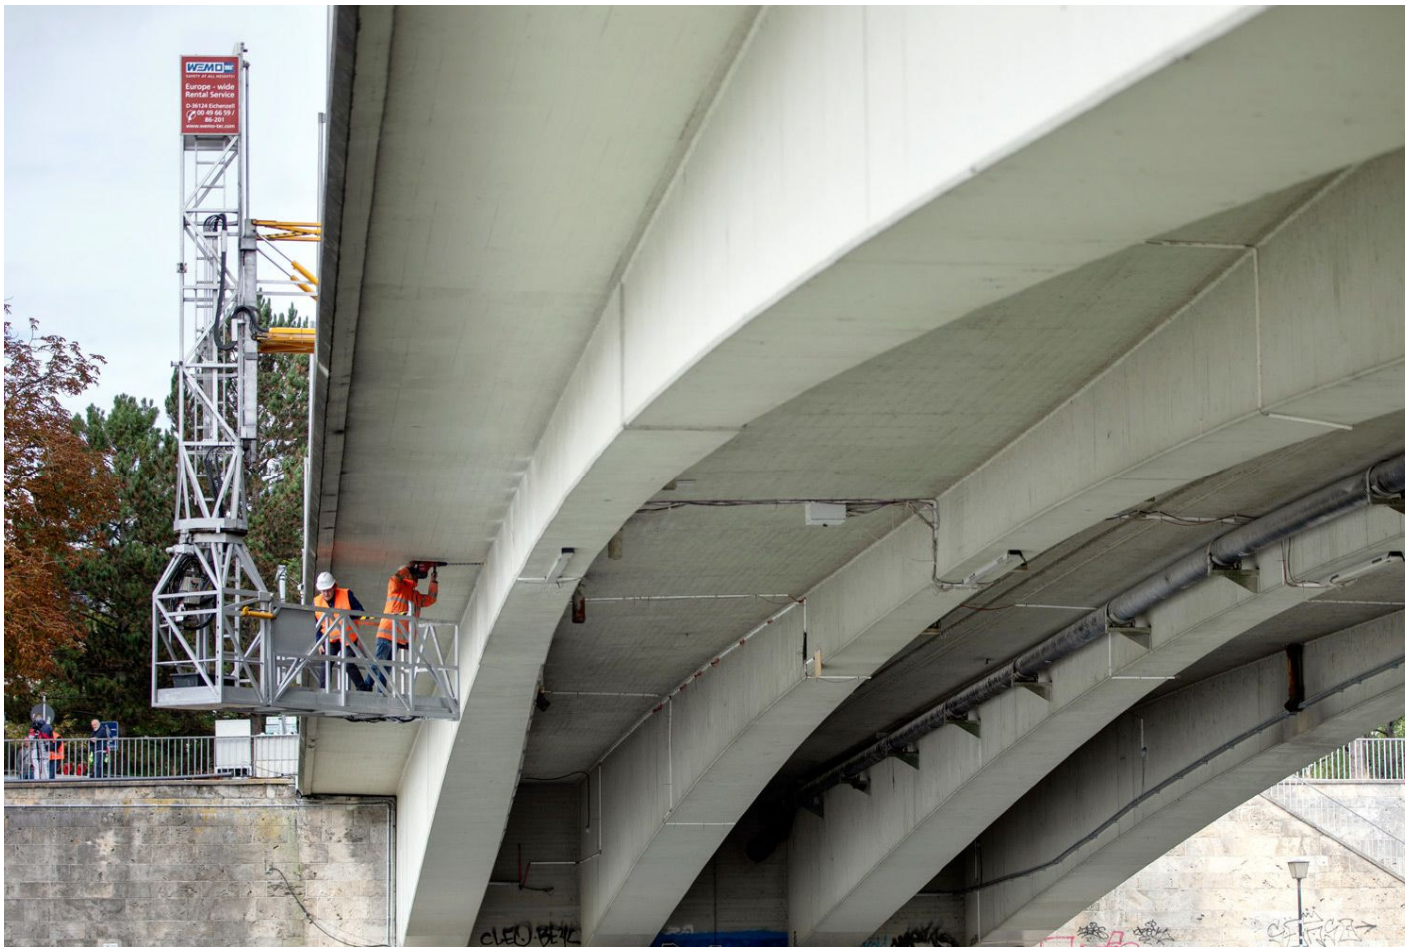
- **Monitoring of Gänstorbrücke, Ulm, Germany**

Objective: Monitor prestressing system of bridge (severe corrosion detected) until it is replaced with new bridge to ensure public safety.

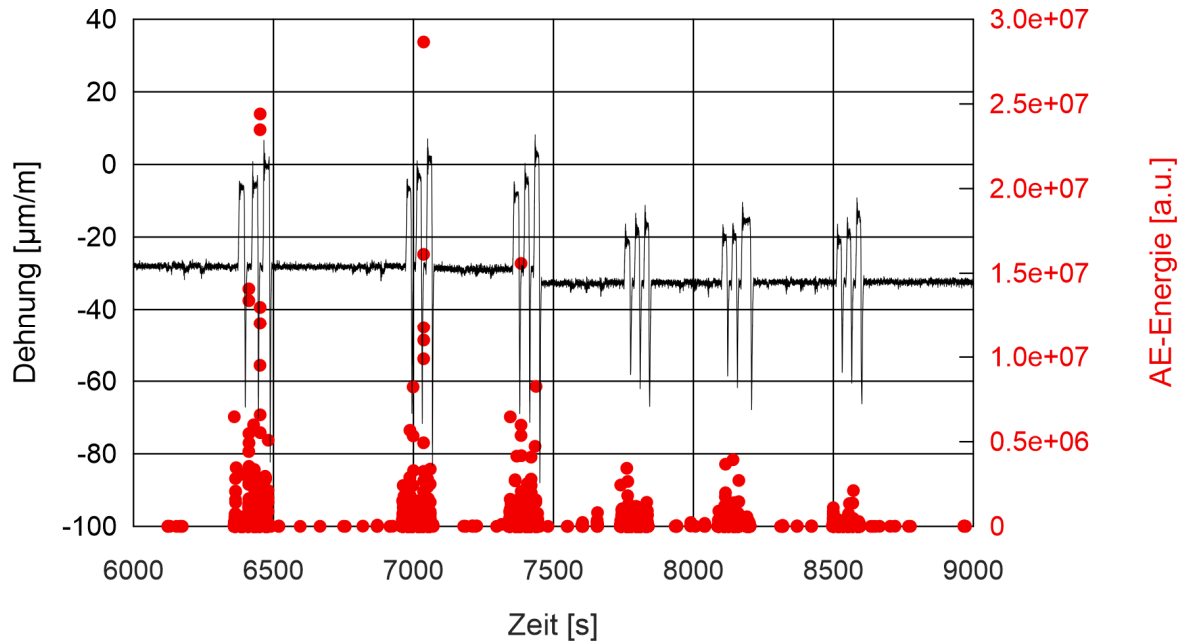
Case study 4: Sample data

Exceedance of specific thresholds initiate video recording of passing vehicle, allowing legal enforcement if necessary.
