BRIDGE WATCH: ASSESSMENT AND MONITORING OF EXISTING INFRASTRUCTURES

Giulio Zani

Politecnico di Milano

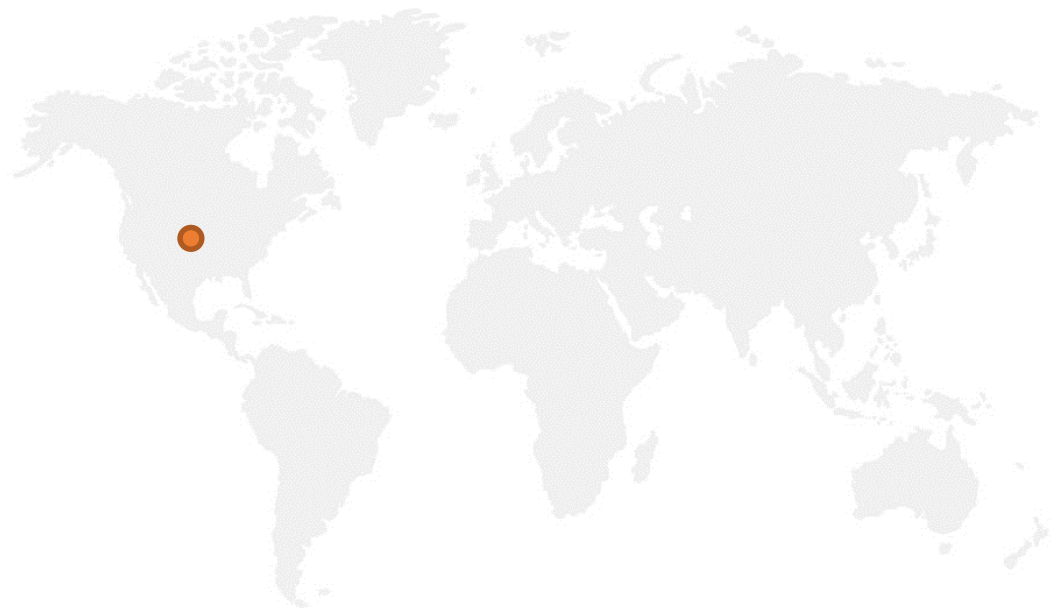
U.S. highway bridges by age and condition

- No deficiencies
- Functionally obsolete
- Structurally deficient

Nearly 30% rated as substandard in 2001

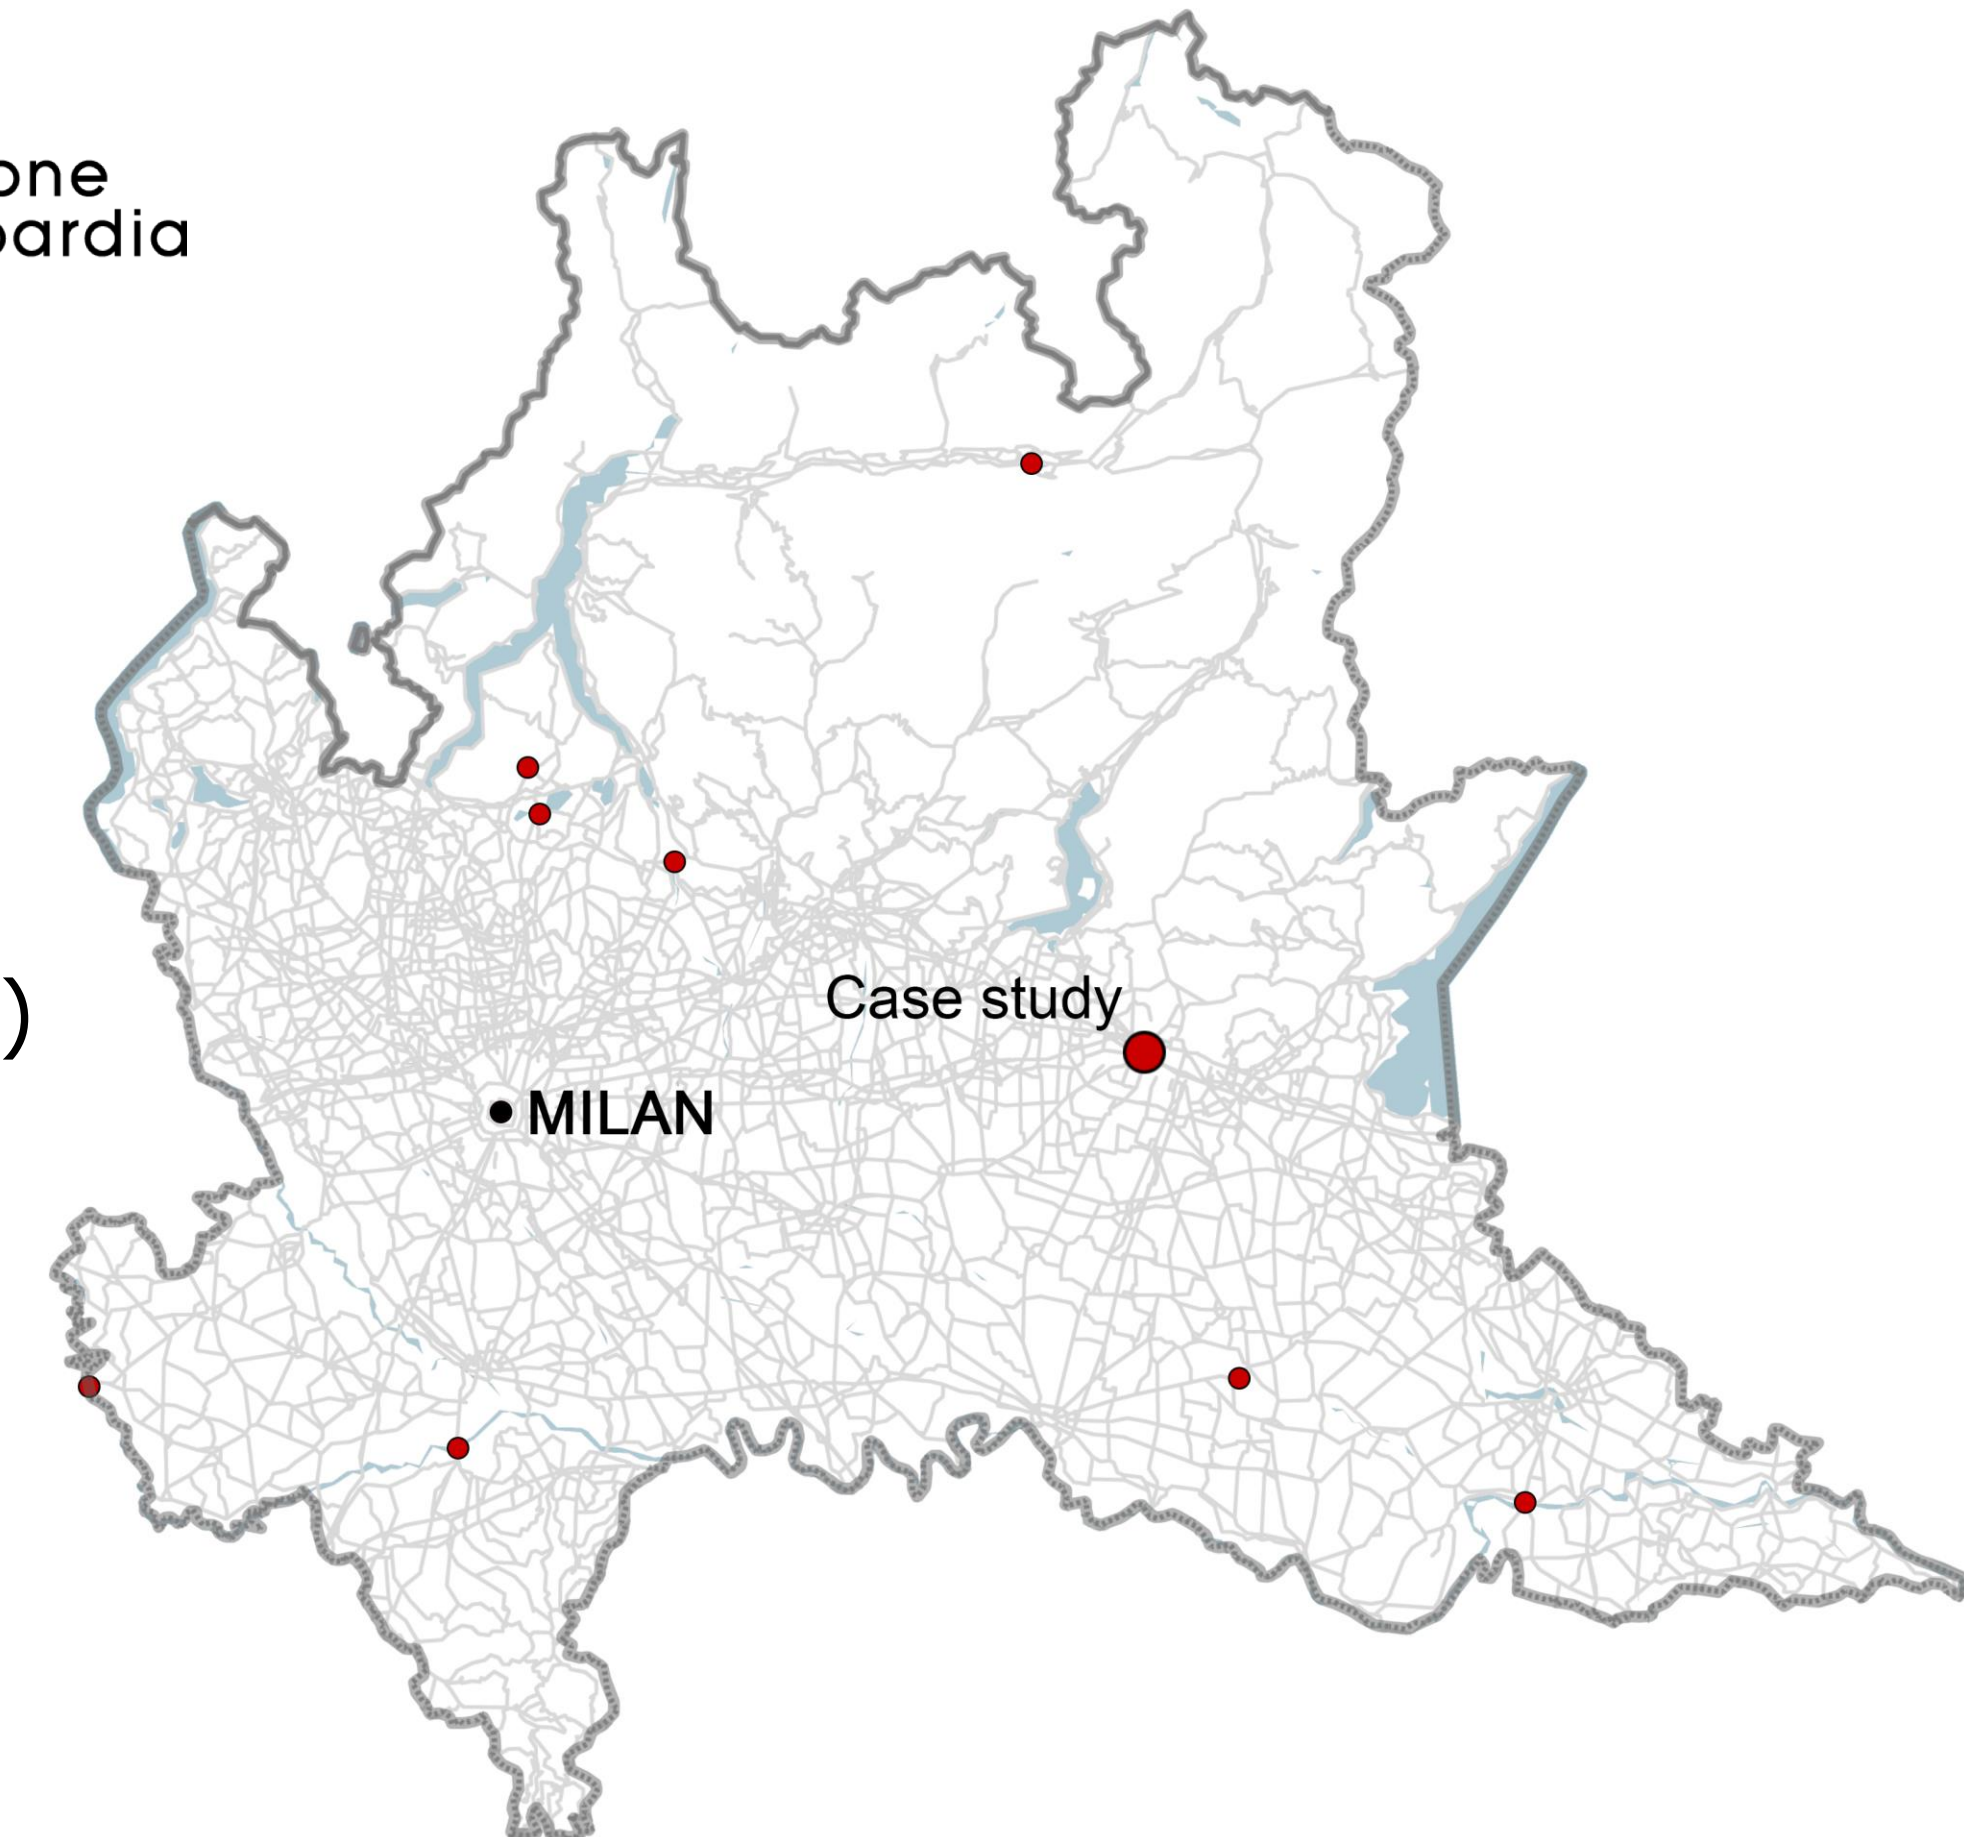
Multicellular RC bridge

Built in the 1950s

Total length 42.8 m

3 spans

Variable depth 1.4 - 2.8 m

2 piers on deep pile foundations

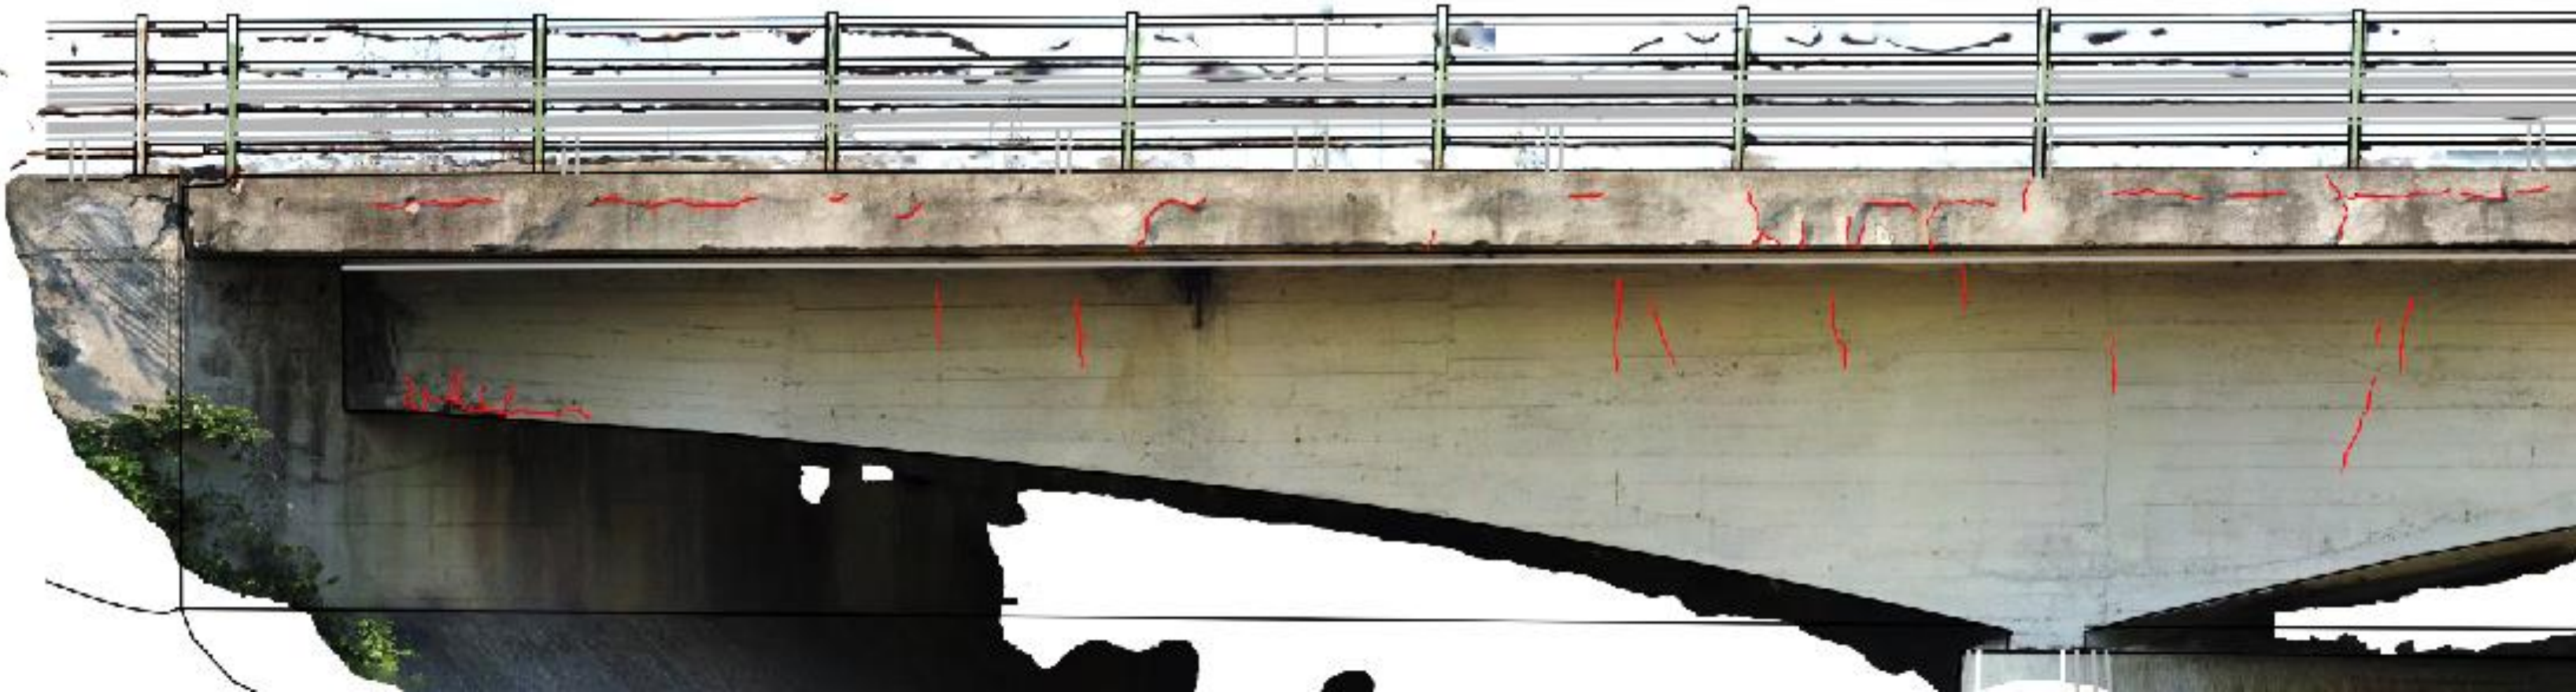
Reconstruction of the cracking pattern
